RAPID BIOASSESSMENT OF THE
LITTLE PIPE CREEK WATERSHED
USING BENTHIC MACROINVERTEBRATES

October 1995

for the Soil and Water Conservation District of
Miami County, Indiana

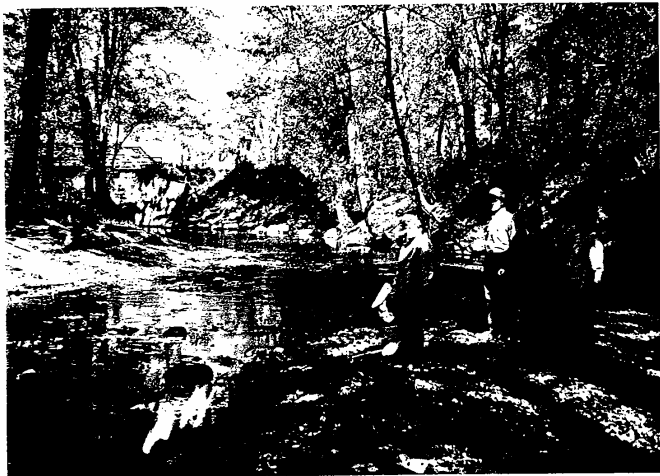
Little Pipe Creek
Lower Watershed
Site 4

Site 4 is downstream from a major tributary draining the westernmost quadrant of the Little Pipe Creek watershed. It is possible that inputs from this tributary may be contributing to the lower water quality at Site 4. ✓

5. Use bioassessment to monitor the unnamed tributary draining the westernmost quadrant of the watershed. This should help determine whether the tributary is contributing to observed water quality problems at Site 4.

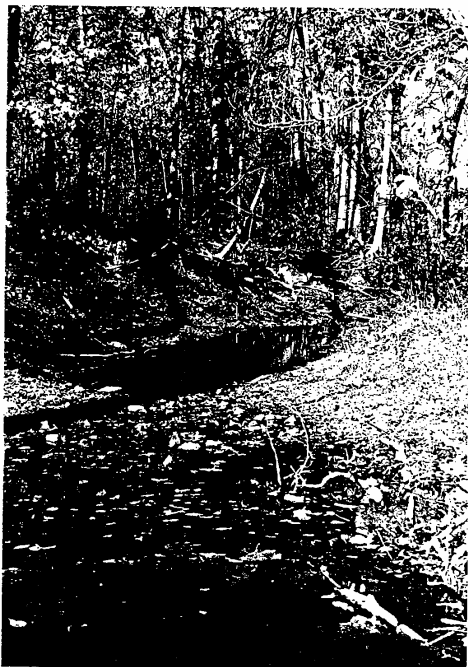
Little Pipe Creek
Upper Watershed
Site 2

The scores indicate that the lowest habitat value in this study was at Site 2 (Upper Little Pipe Creek near CR 500 S). Habitat at Site 2 was hampered by a paucity of stable bottom substrate and instream cover, by the narrowness of its riparian buffer zone, and by little water flow. Sediment deposition appeared to be heavier at this site than elsewhere in the watershed. Habitat value of Little Pipe Creek increased in a downstream direction, and attained a score that was within 89% of the reference site by the time the stream joined the Wabash River.
